Dundalk Marine Terminal (DMT) RoRo Demolition and Bulkhead Rehabilitation

Port of Baltimore, Maryland Port Administration

Jeffrey Cerquetti, MCE, PE
Vice President, Facilities Structures and Coastal Engineering

March 23, 2016

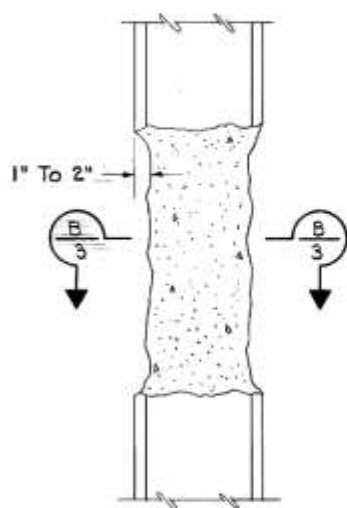
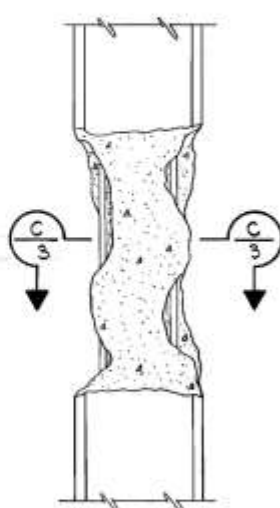
EXISTING PILE DETERIORATION

TYPE 1

TYPE 2

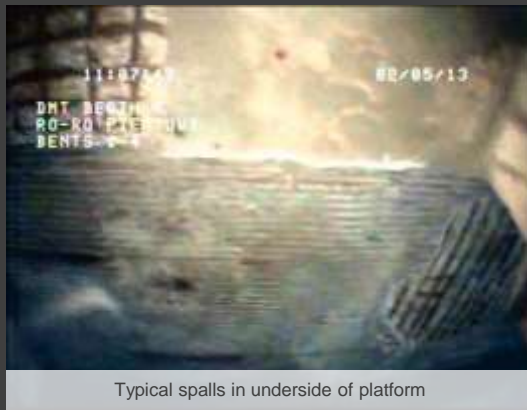
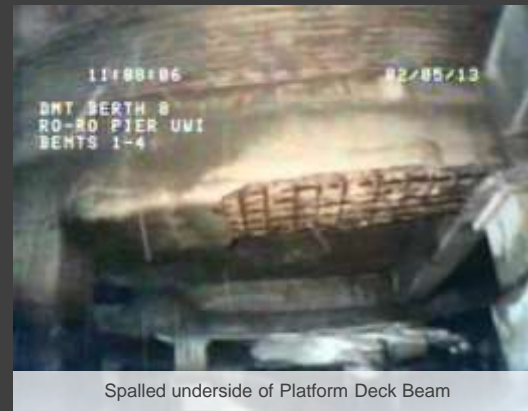
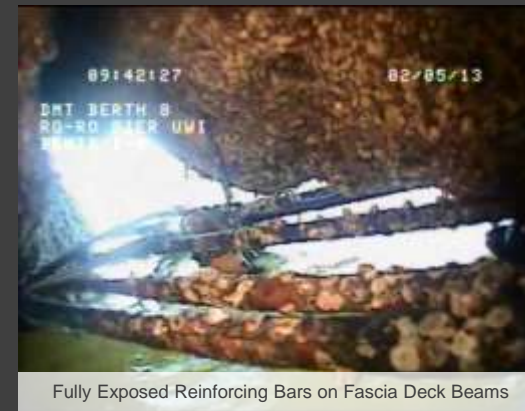
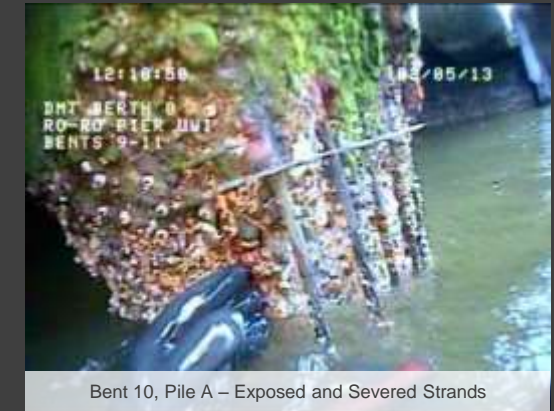
- Condition of piles restricted pulling during demolition
- Timber and concrete pile section obstructions on the channel bottom
- Underside of concrete deck and deck beams spalled fully exposing reinforcing bars
- Prestressed concrete piles broken and defective with exposed strands

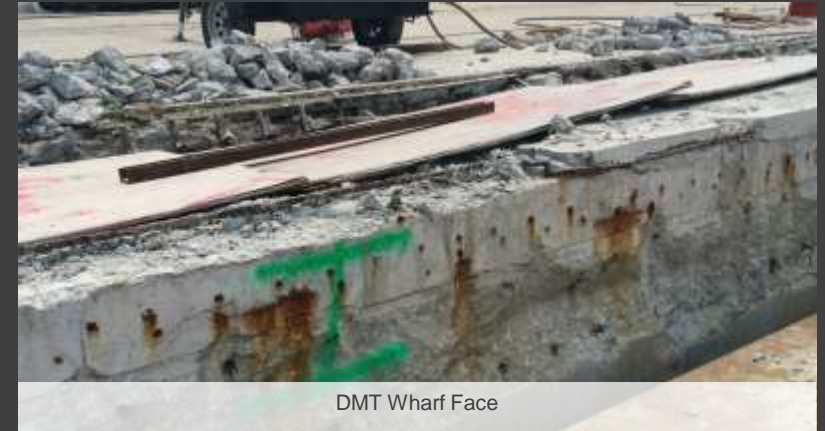
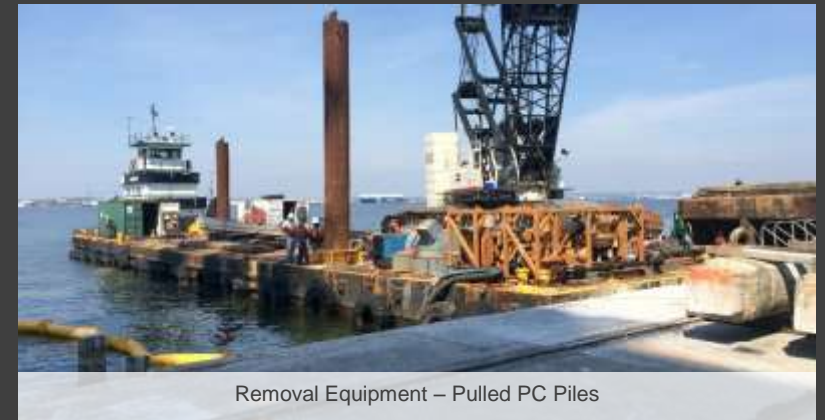
- Face repairs from rusted connections
- Piles under Ro-Ro Platform sawcut and pulled
- Repairs done to wharf sides and face and integrated with new pile supported bollards
