# Deeper Dredging Analysis for Existing Port Structures Houston Ship Channel

The client is looking to dredge the Turning Basin Terminal to a deeper depth, from existing 32ft + 2ft to 40ft+2ft.

# Turning Basin Wharves 47 and 48 Project

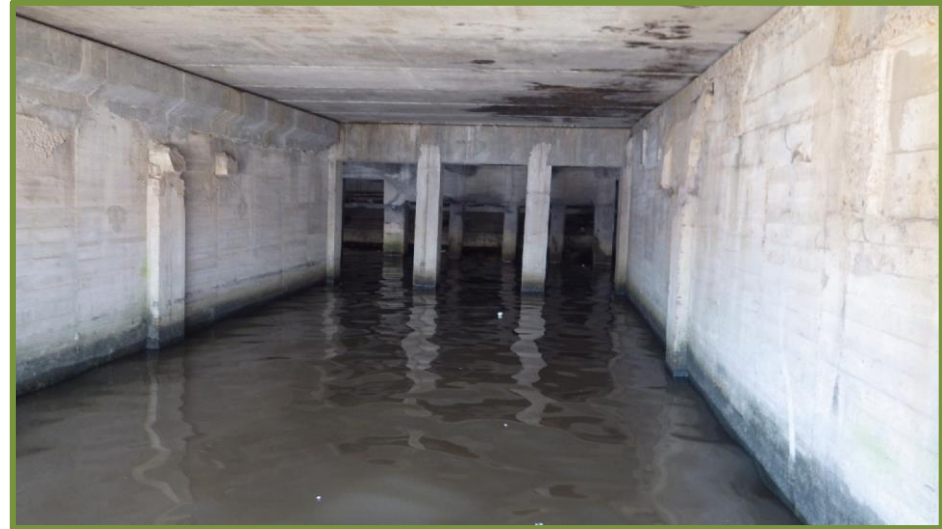
Berthing line

View from waterside

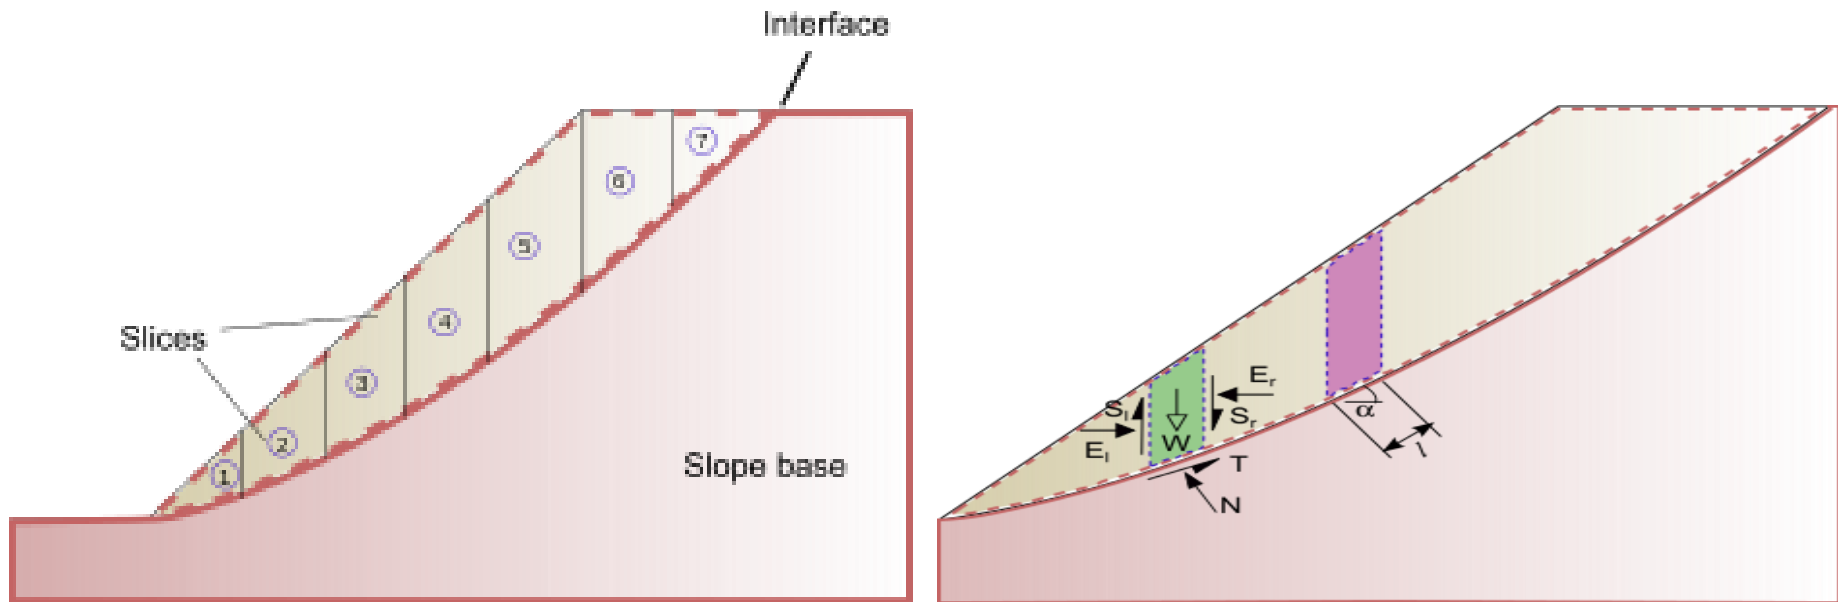
# Analysis Method: Modified Bishop Method

Analysis Software : GSTABL

FOS accepted in industry : 1.2

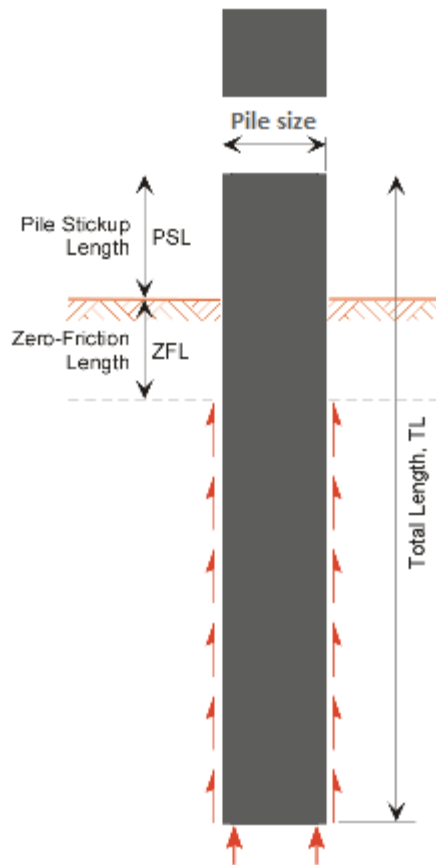
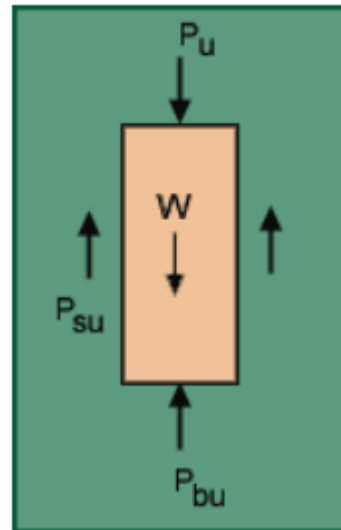
# Analysis Method: Compression Pile Capacity

Analysis Software  
: APILE  
FOS accepted in  
industry: 2

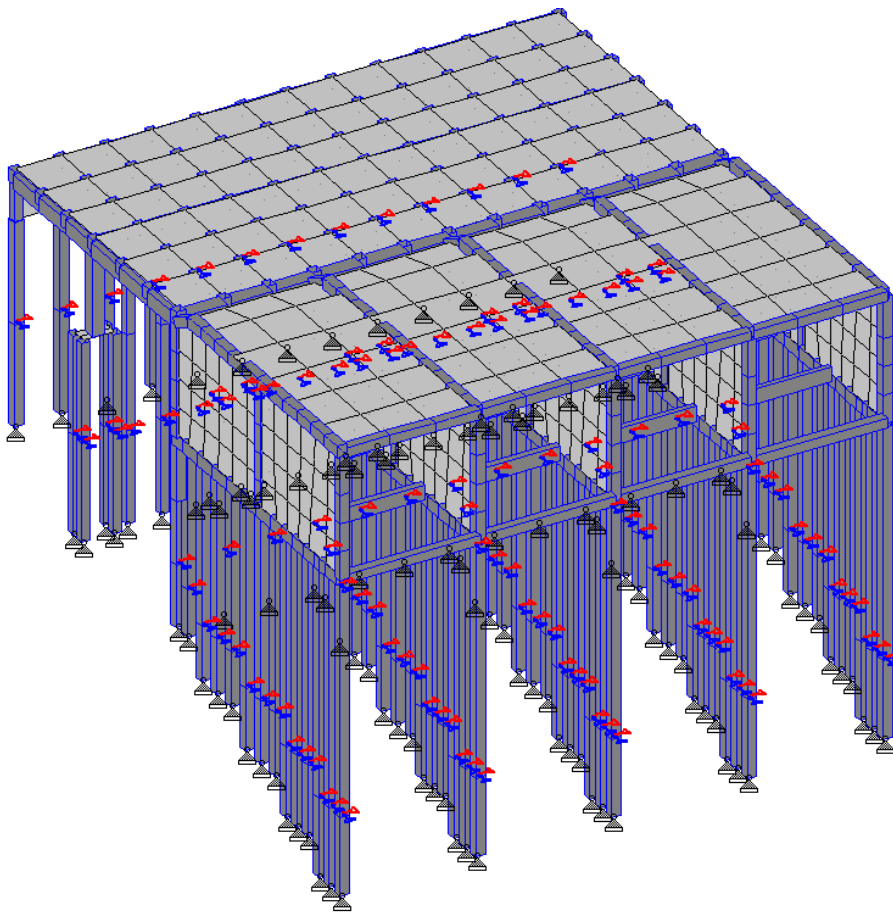
# Analysis Method: Pile Capacity Requirements

Analysis Software : STAAD Pro

- *Dead Load*
- *Live load*
- *Lateral earth pressure*
- *Hydrostatic pressure*
- *Mooring loads*
- *Berthing loads*

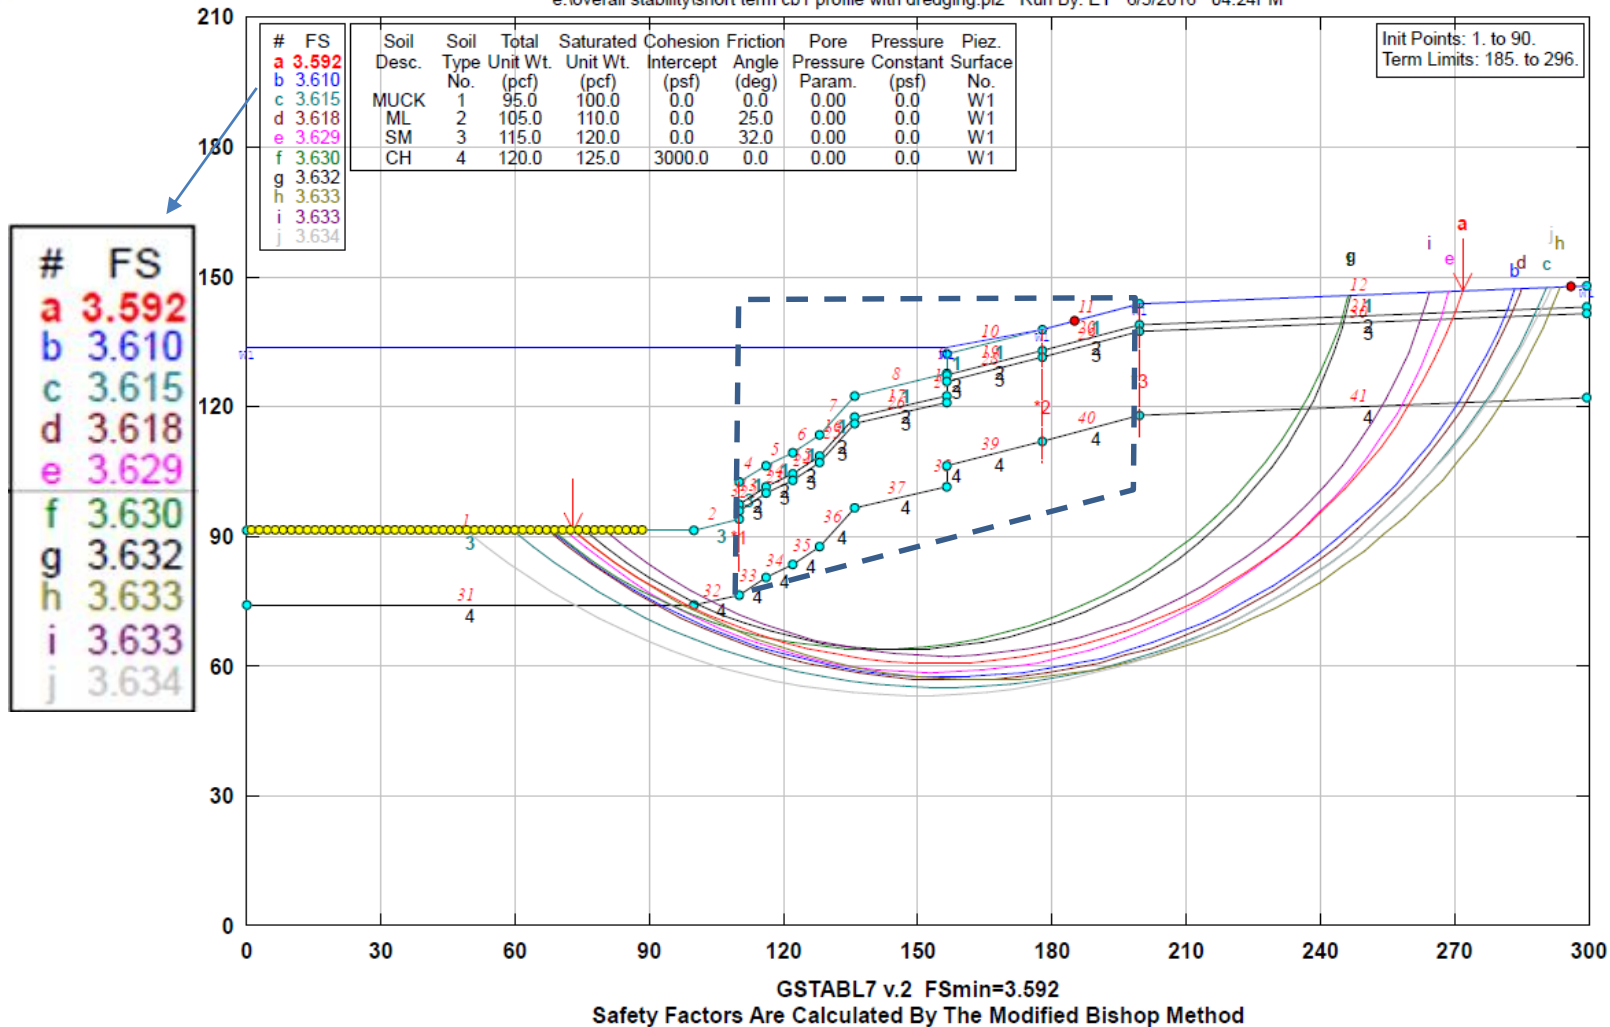
# Global Slope Stability

## Short term - CB1 profile with dredging EL -42

e:\overall stability\short term cb1 profile with dredging.pl2 Run By: ET 6/3/2016 04:24PM

Global stability factor of safety is acceptable. Global sliding failure is not indicated.

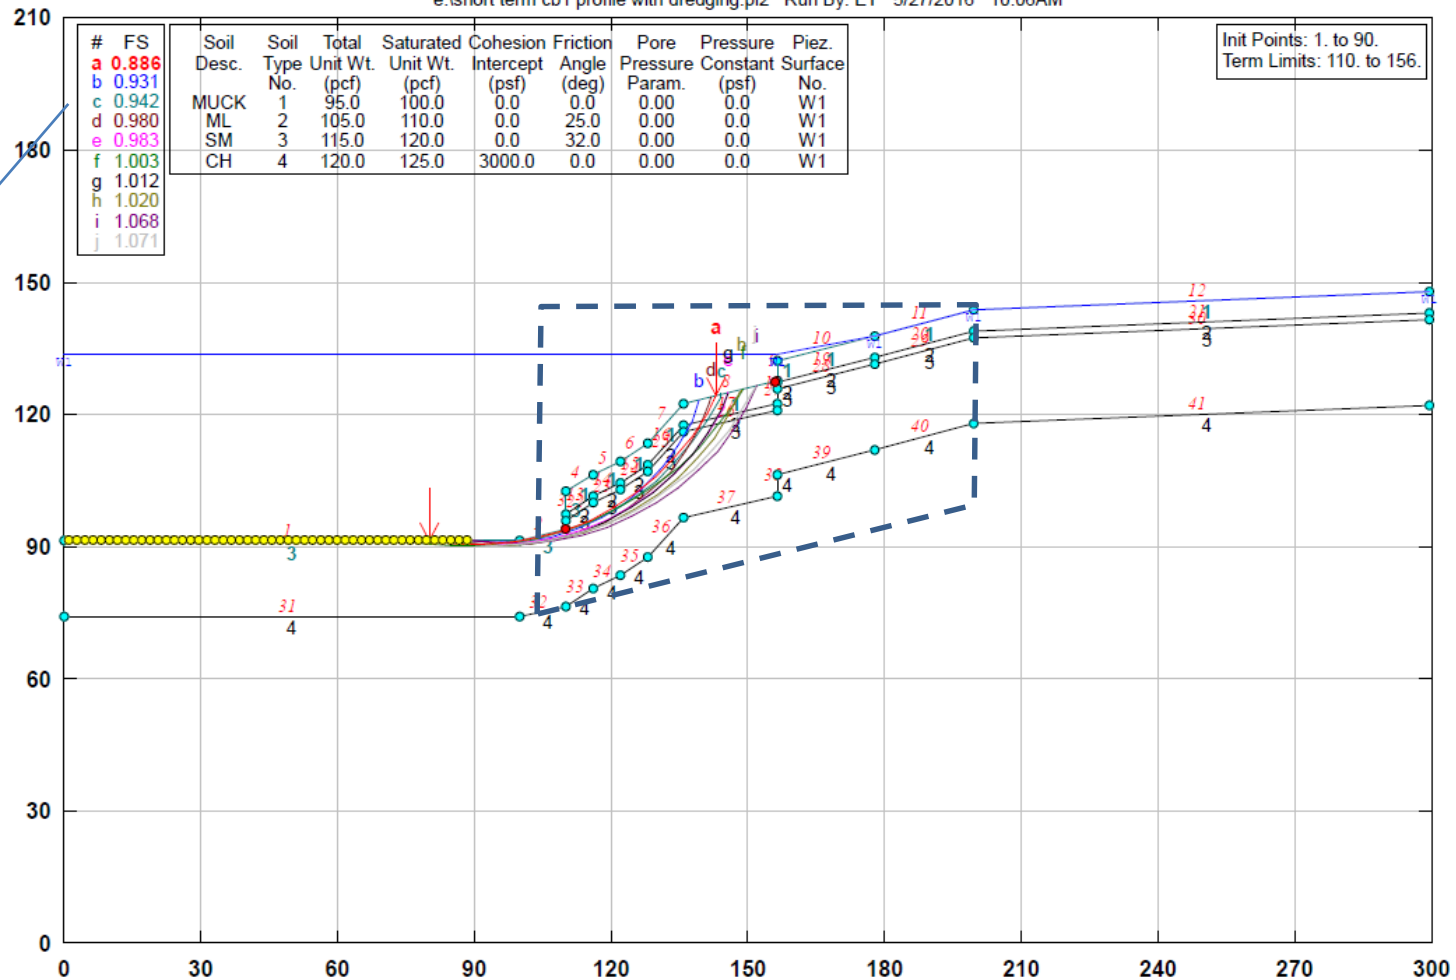
# Local Slope Stability

## Short term - CB1 profile with dredging EL -42

e:\short term cb1 profile with dredging.pl2 Run By: ET 5/27/2016 10:06AM

Local slope stability FOS less than 1 for multiple slip planes, slope failure is indicated

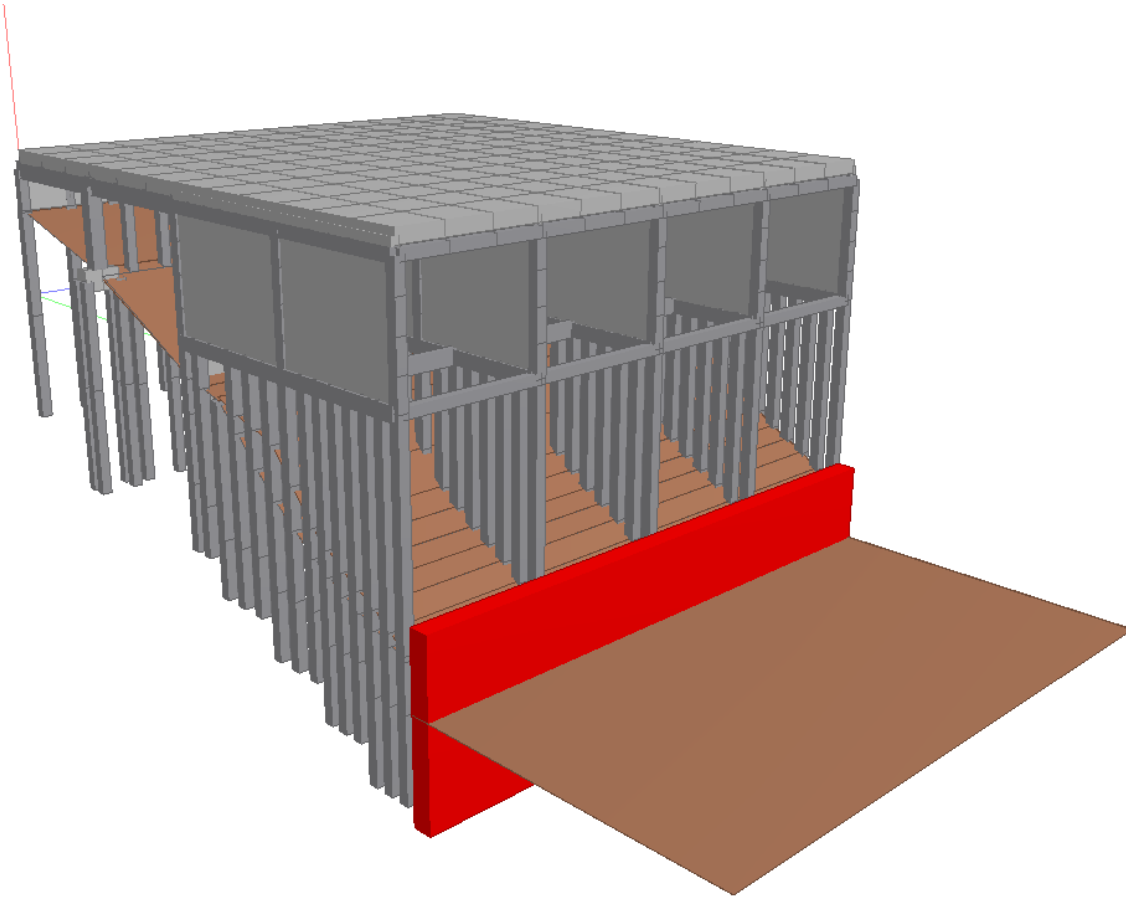
Add a toe-wall

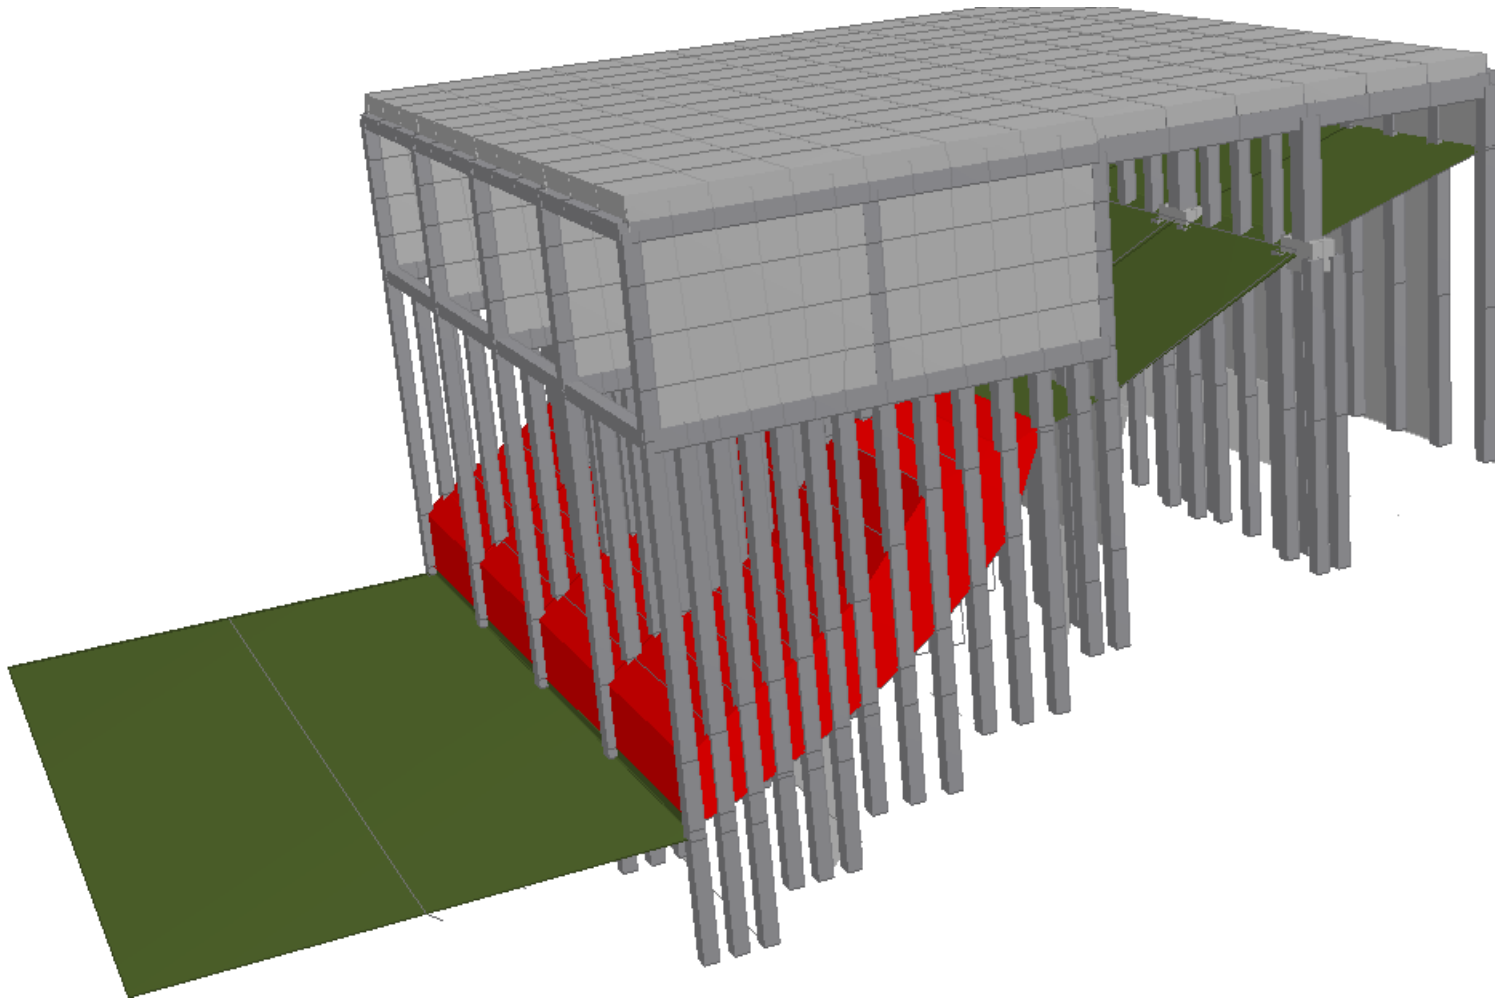
Soil Stabilization
