Dundalk Marine Terminal (DMT) RoRo Demolition and Bulkhead Rehabilitation

Port of Baltimore, Maryland Port Administration

Jeffrey Cerquetti, MCE, PE
Vice President, Facilities Structures and Coastal Engineering

March 23, 2016

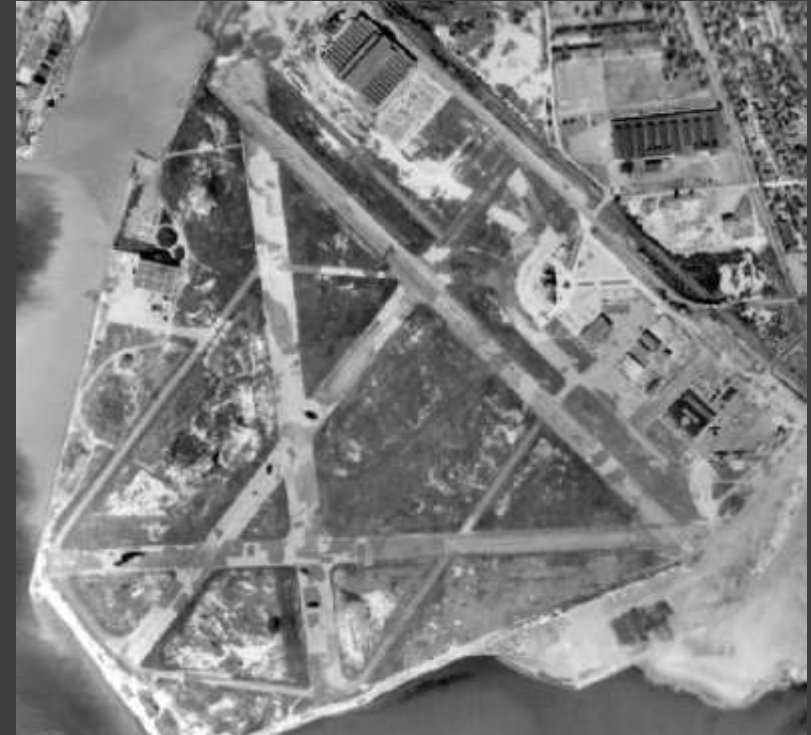
1957 Aerial view of Harbor Field still operating, although runways appear in extremely rough condition prior to purchase by MPA.

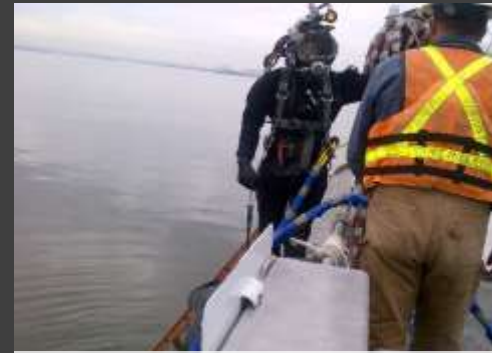
Engineering Divers conducting an underwater structural assessment.

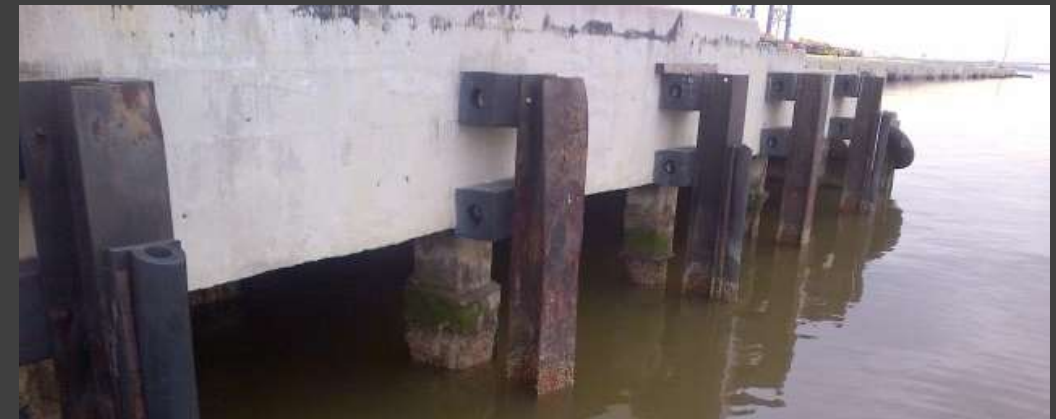
Waterline Fenders and Piles

- Condition of piles restricted pulling during demolition
- Timber and concrete pile section obstructions on the channel bottom
- Underside of concrete deck and deck beams spalled fully exposing reinforcing bars
- Prestressed concrete piles broken and defective with exposed strands
